CERTIFICATE OF ANALYSIS

Certificate No :	AMC/nC2106/040	
Sample Log Code :	nC2106/009	
Sample Received Date :	01-Jun-2021	
Issuance Date :	15-Jun-2021

: Natural Rubber Feeding Teats

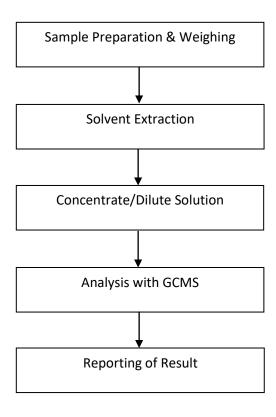
Flow Chart for Analysis of Phthalates Content
